**From:** Wess Sorensen <WSorensen@archcoal.com>  
**To:** <jdefrees/r4\_m-l@fs.fed.us>, <pbaker@state.ut.us>, <phess@state.ut.us>  
**Date:** 8/31/00 12:47PM  
**Subject:** PHOTOS OF ROCK SHELTER ON 150 ACRES

The following photos were taken today 8/31/00 of the rock shelter on the 150 acre lease modification. The shelter was recently undermined with the longwall as planned. The roof has spalled in through out the shelter. The thickness at the center of the span is about 2 ft and feathers out towards the edges. The cracks shown in the photos are located about 1500 ft north of the shelter. While in the ravine, I could here the rocks buckling and breaking similar to an active cave line on a pillar section underground. I could not hear the popping when I was up on the sage brush flat.

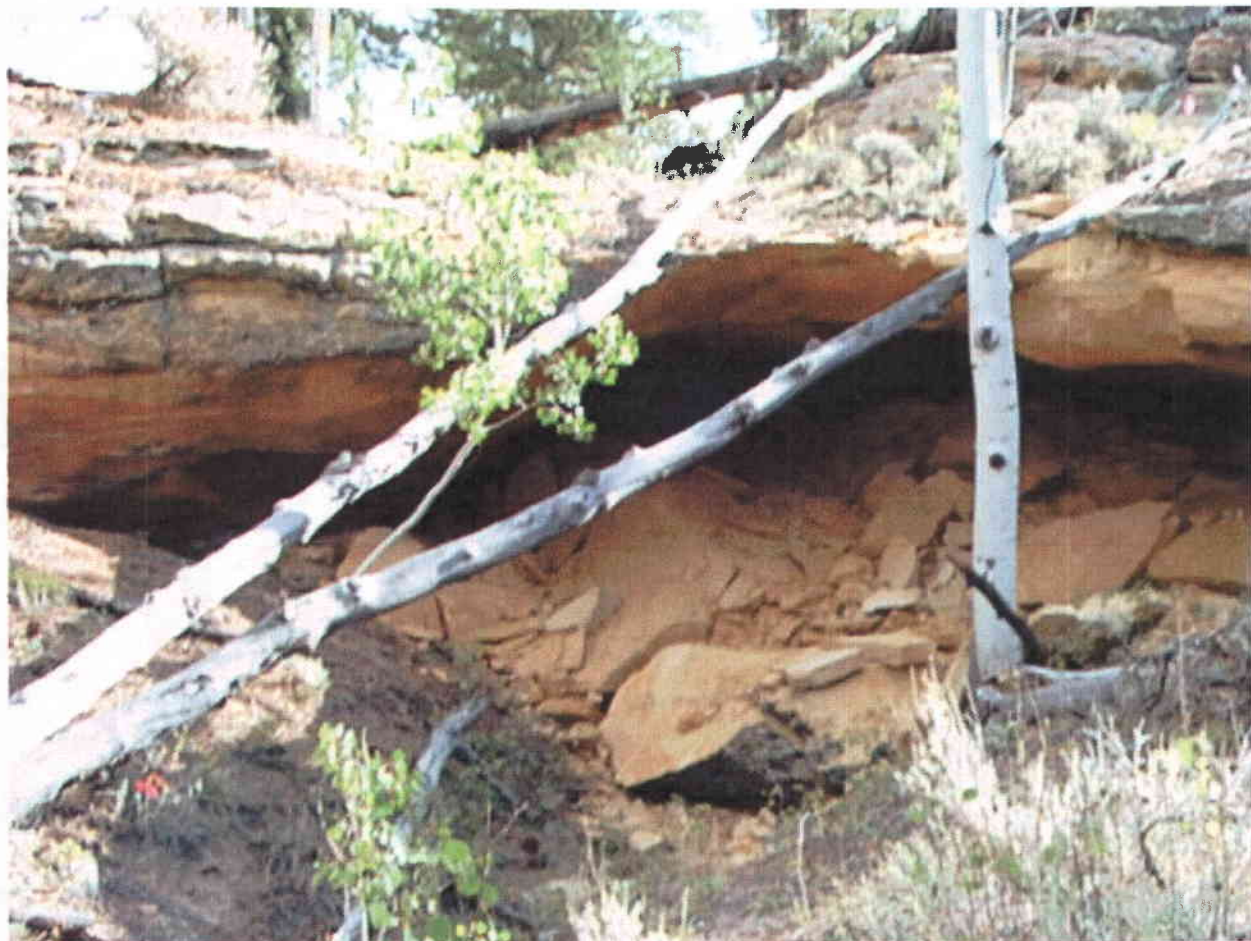
Subsidence cracks on plateau  
above rock shelter 42SV2492

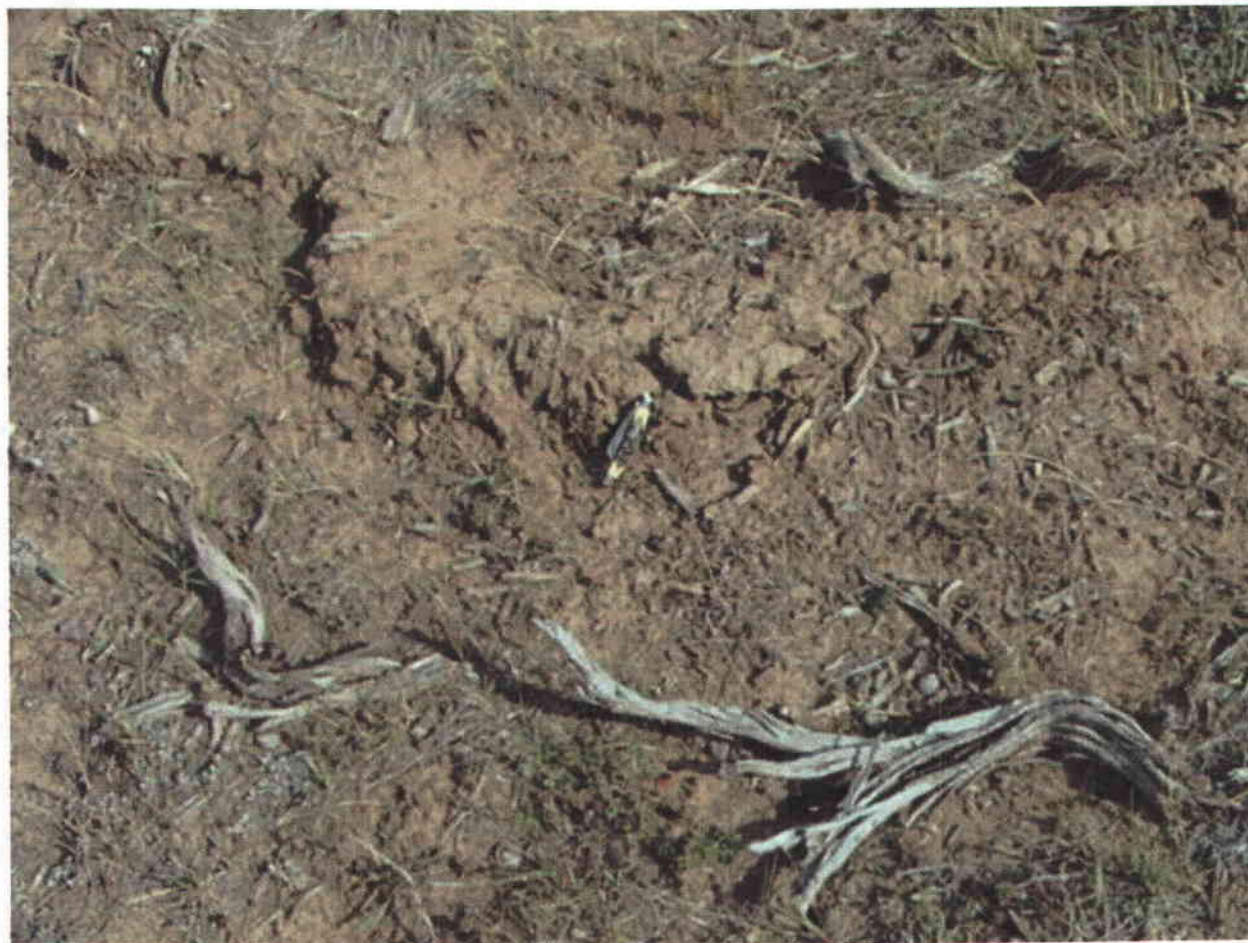
ACT/041/002 Incoming  
Subsidence cracks on plateau above  
Rock shelter # 42502492
